WRDC-TR-89-4055

COMPENDIUM OF FRACTOGRAPHIC DATA FOR COMPOSITE  
MATERIALS

INTERIM REPORT  
Covering 9-22-86 through 10-31-88

C. Hua  
M. Yamashita  
Boeing Advanced Systems  
P.O. Box 3707  
Seattle, WA 98124

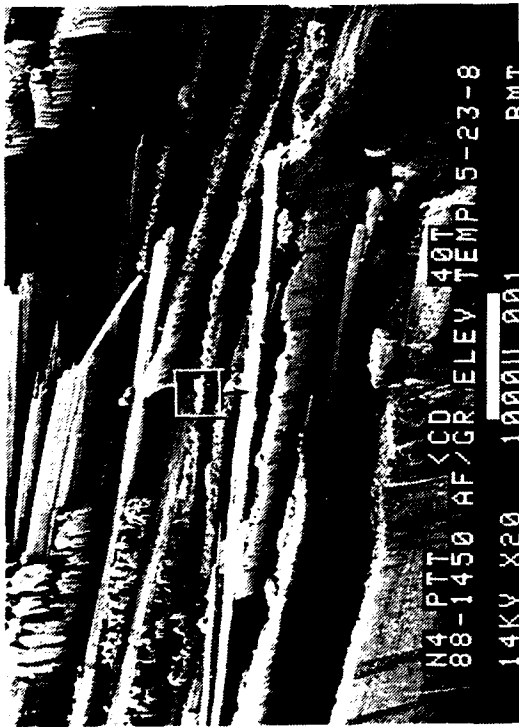
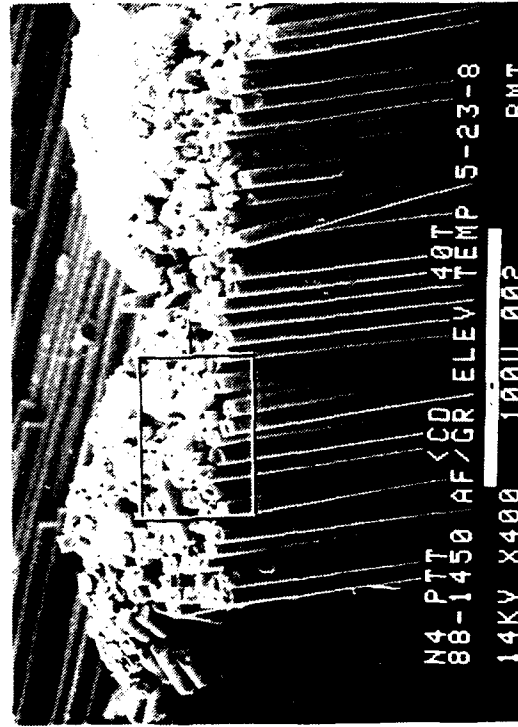
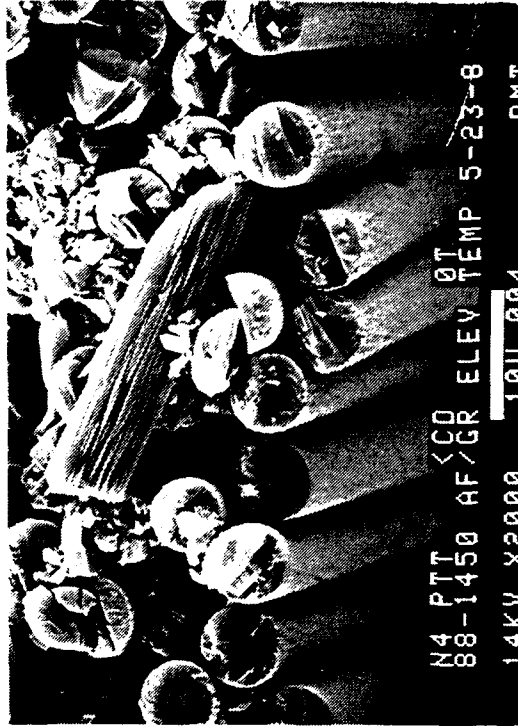
Figure 4.4-44. SEM Fractographs of Elevated Temperature, Translaminar Tension Fracture

**Translaminar Tension.** Visual observation of the translaminar tension fracture surface exposed to 2000°F flame revealed a surface with rows of bare fibers. Most of the resin matrix was burned off near the fracture surface.

The bare fibers were especially visible in the SEM fractographs. Radial patterns typically seen under translaminar tension failure mode were observed on the fiber ends prior to the flame test was no longer present afterwards (Fig. 4.4-44). Instead, the fibers showed extensive cracking on their end surfaces.

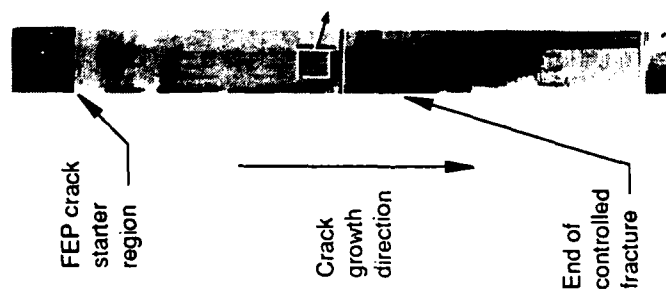
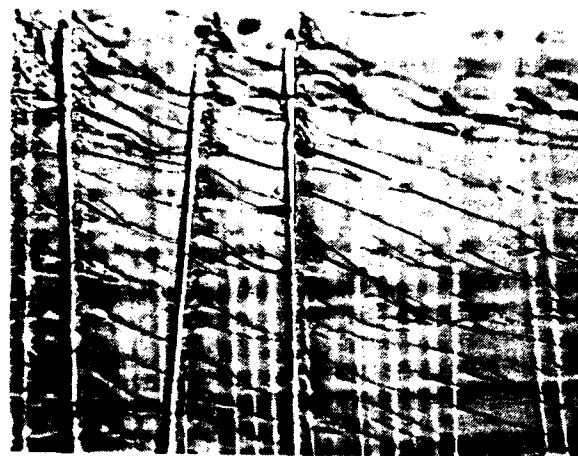
Figure 4.4-45. Optical Photomicrographs of Interlaminar Mode I Tension, 0/90 Fracture After Water Immersion (160 F)

**Interlaminar Mode I Tension.** Visual observation of the water immersion and high humidity specimens revealed smooth glassy fracture surfaces as commonly seen in interlaminar Mode I tension specimens at RT/dry conditions (Fig. 4.4-45 and 4.4-46). At higher magnifications under the optical microscope, rivermarks and resin microflow were seen. Work done in the previous contract, C-5010, determined that these features reveal an overall crack propagation direction. However, it was noted that the rivermarks in these specimens were not as distinct as they were in the RT/dry specimens (Fig. 4.4-47 and 4.4-48). In general, the humidity and water immersion specimens exhibited nearly identical fracture characteristics.

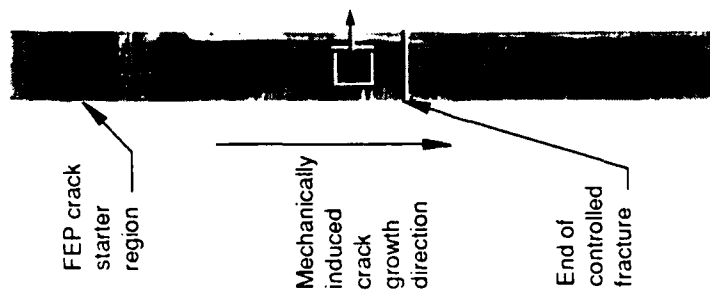
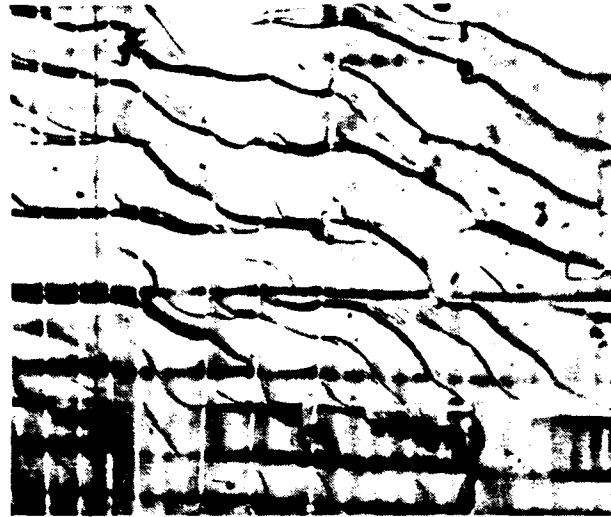
Figure 4.4-55. Optical Photomicrographs of Interlaminar Mode I Tension, 0/90 Fracture of Undercured Specimen

adhesion. The fibers were easily separated from each other and exhibited a feathery texture. Because of the undercuring process, some of the fibers never reached the state of wetting, causing loose fibers within the laminate. At higher magnifications, rivermarks and resin microflow were seen (Fig. 4.4-55).

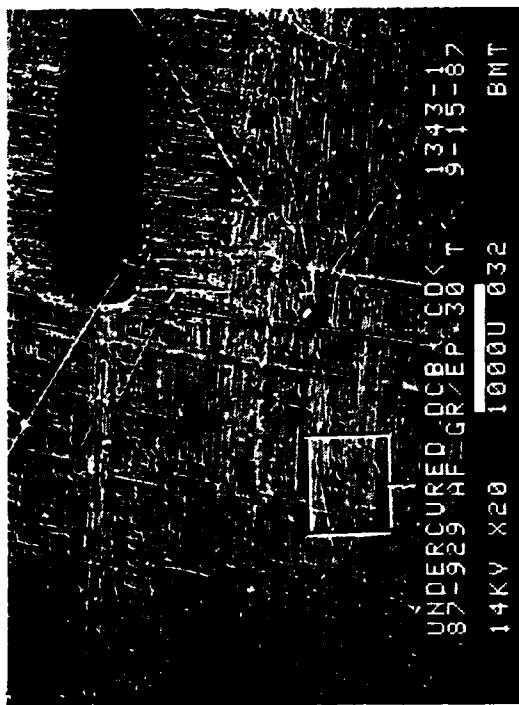
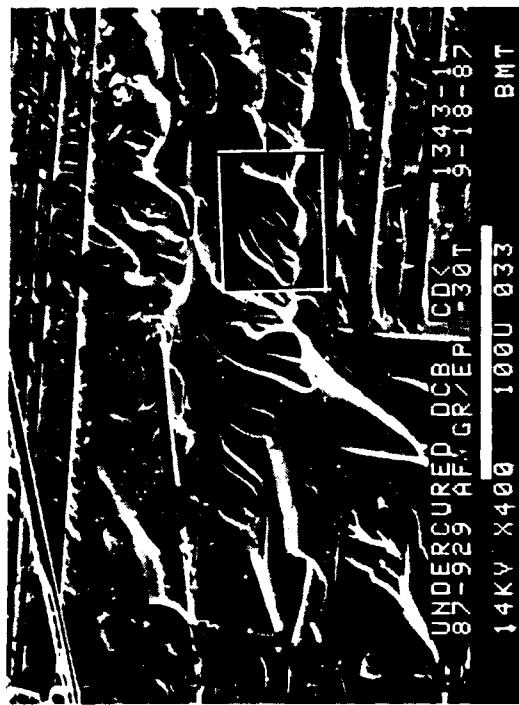
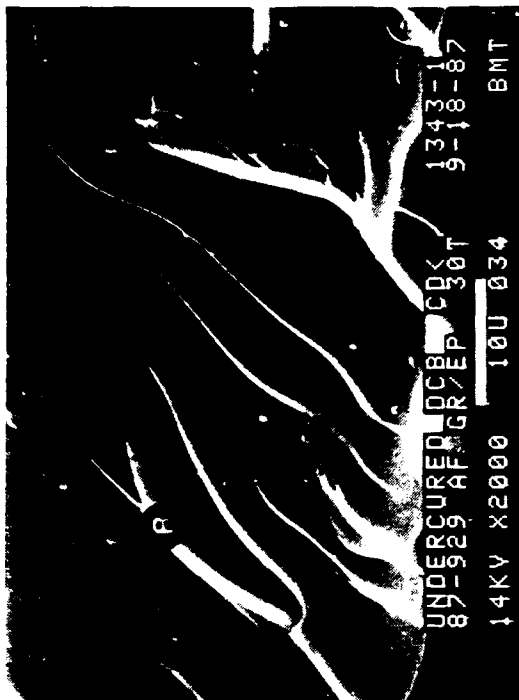
Figure 4.4-56. SEM Fractographs of Interlaminar Mode I Tension, 0/90 Fracture of Undercured Specimen

The SEM analysis revealed a fracture surface typically seen in an RT/dry specimen (Fig. 4.4-56). However, optical observation showed many stray fibers indicating the lack of fiber wetting from the undercuring process. The rivermarks were clearly observed and showed the overall crack propagation direction.

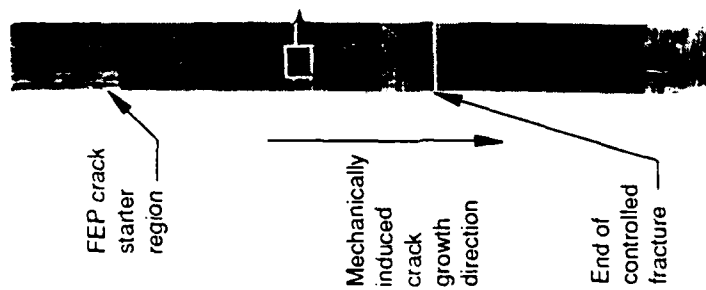
Figure 4.4-57. Optical Photomicrographs of Interlaminar Mode II Shear, 0/90 Fracture of Undercured Specimen

Interlaminar Mode II Shear. Visual observation of the fracture surface revealed a flat but milky appearance when the specimen was held at an angle to the light. Like the interlaminar Mode I tension specimen, the fibers appeared to have a feathery texture and the laminate quality was poor. At higher magnifications, hackles were observed (Fig. 4.4-57).

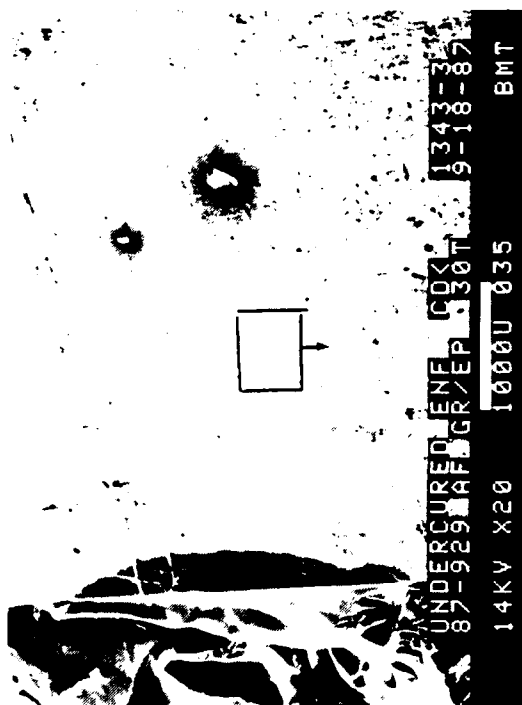
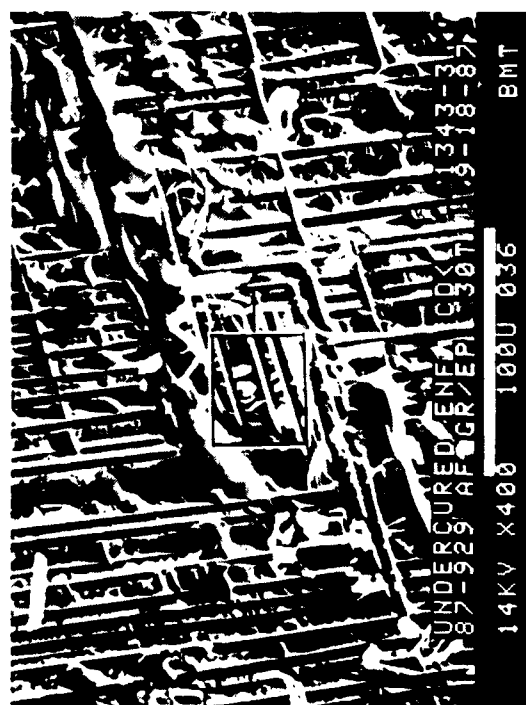
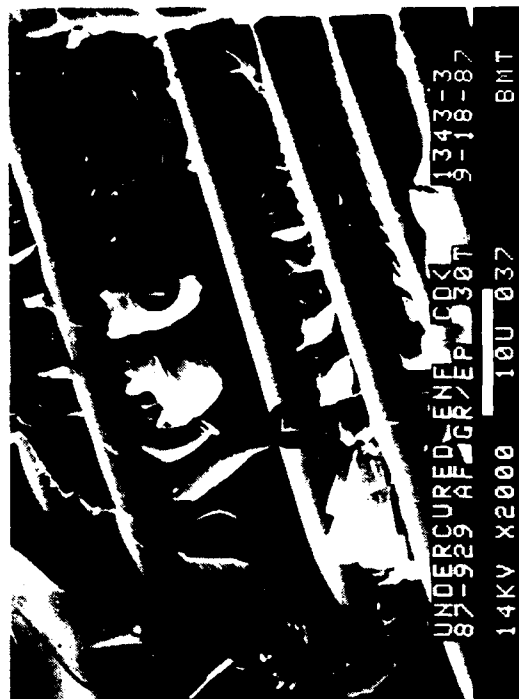
Figure 4.4-58. SEM Fractographs of Interlaminar Mode II Shear, 0/90 Fracture of Undercured Specimen

The SEM analysis revealed a fracture surface with fiber/matrix separation characterized by an adhesive-type fracture (Fig. 4.4-58). This was evidenced by the practically featureless surface. As in the Mode I tension specimens, the lack of fiber wetting caused loose fibers to occur along the fracture surface.

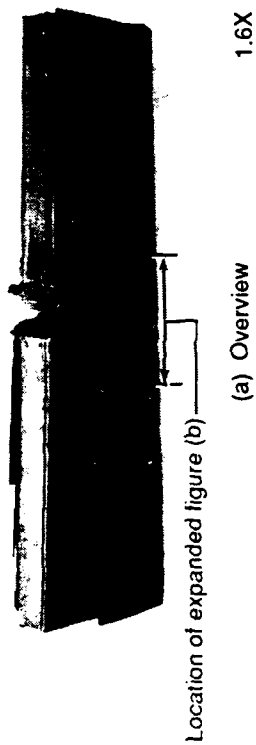
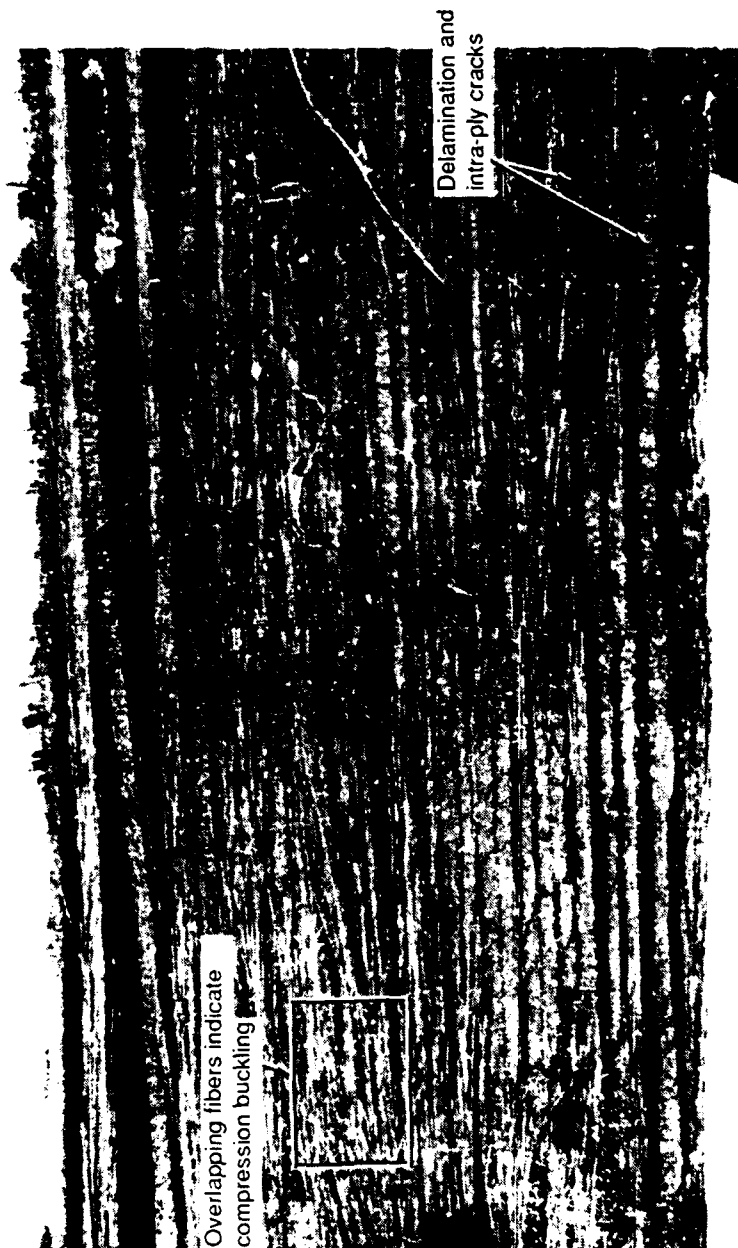
Figure 4.4-59. Optical Photomicrographs of Damaged Region of Translaminar Tension Fracture of Undercured Laminate

Translaminar Tension. The specimens did not fracture as intended but rather buckled. The undercuring caused insufficient cross linking in the polymer which lessened the ability of the matrix to support the fiber (Fig. 4.4-59).

(b) Region on the edge opposite to the notched side

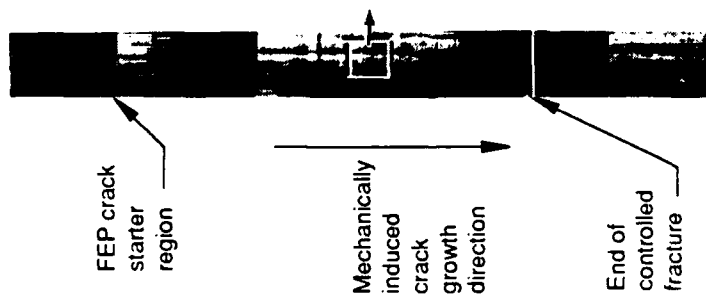
Figure 4.4-60. Optical Photomicrographs of Interlaminar Mode I Tension, 0/90 Fracture of Overcured Specimen

Interlaminar Mode I Tension. Visual observation of the fracture surface revealed the smooth, glassy fracture surface typical of an interlaminar Mode I tension specimen at RT/dry conditions. At higher magnifications, rivermarks and resin microflow were seen (Fig. 4.4-60).

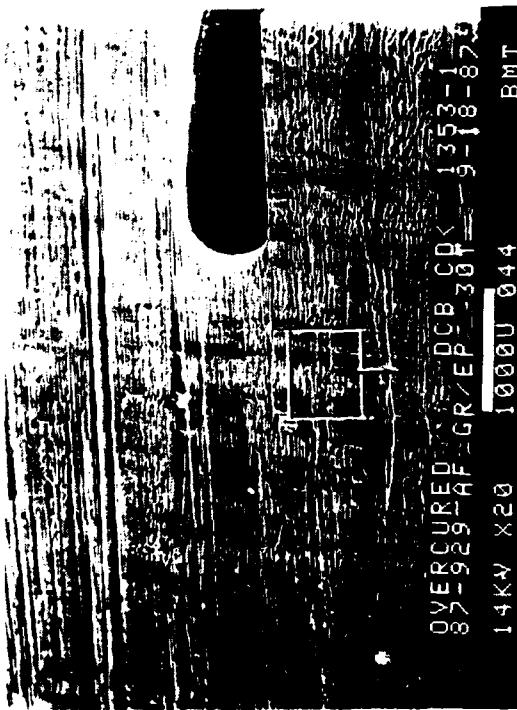
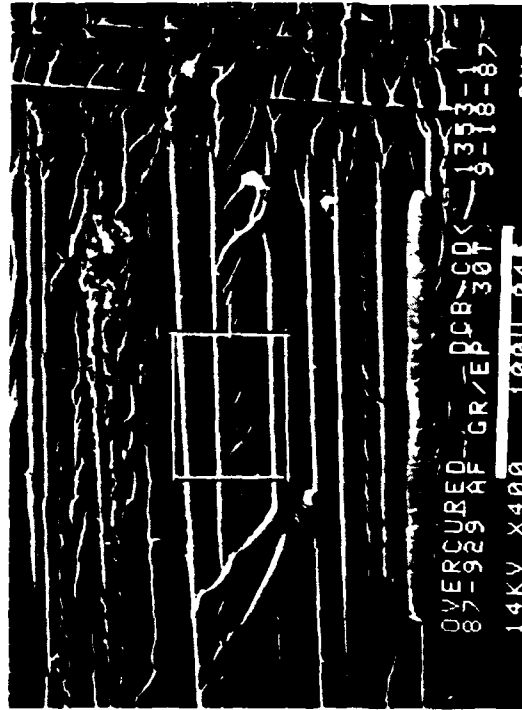
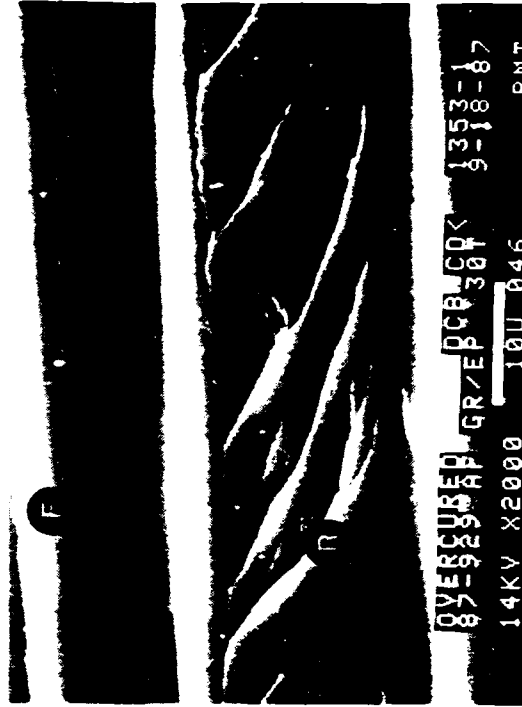
Figure 4.4-61. SEM Fractographs of Interlaminar Mode I Tension, 0/90 Fracture of Overcured Specimen

The SEM analysis revealed a typical RT/dry fracture surface. It is thought that additional cross-linking occurs in double-cured specimens causing the material to become brittle (Fig. 4.4-61). The visual observation of the fracture was inconclusive although it revealed a dry surface characteristic of a brittle material. The rivermarks were clearly observed and showed the overall crack propagation direction.

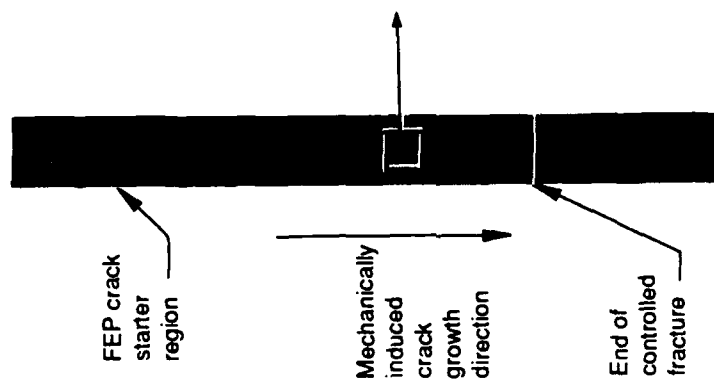
Figure 4.4-62. Optical Photomicrographs of Interlaminar Mode II Shear, 0/90 Fracture of Overcured Specimen

Interlaminar Mode II Shear. Visual observation of the fracture surface revealed the typical flat but milky appearance when the sample was held at an angle to the light. At

higher magnifications, hackles were observed (Fig. 4.4-62).

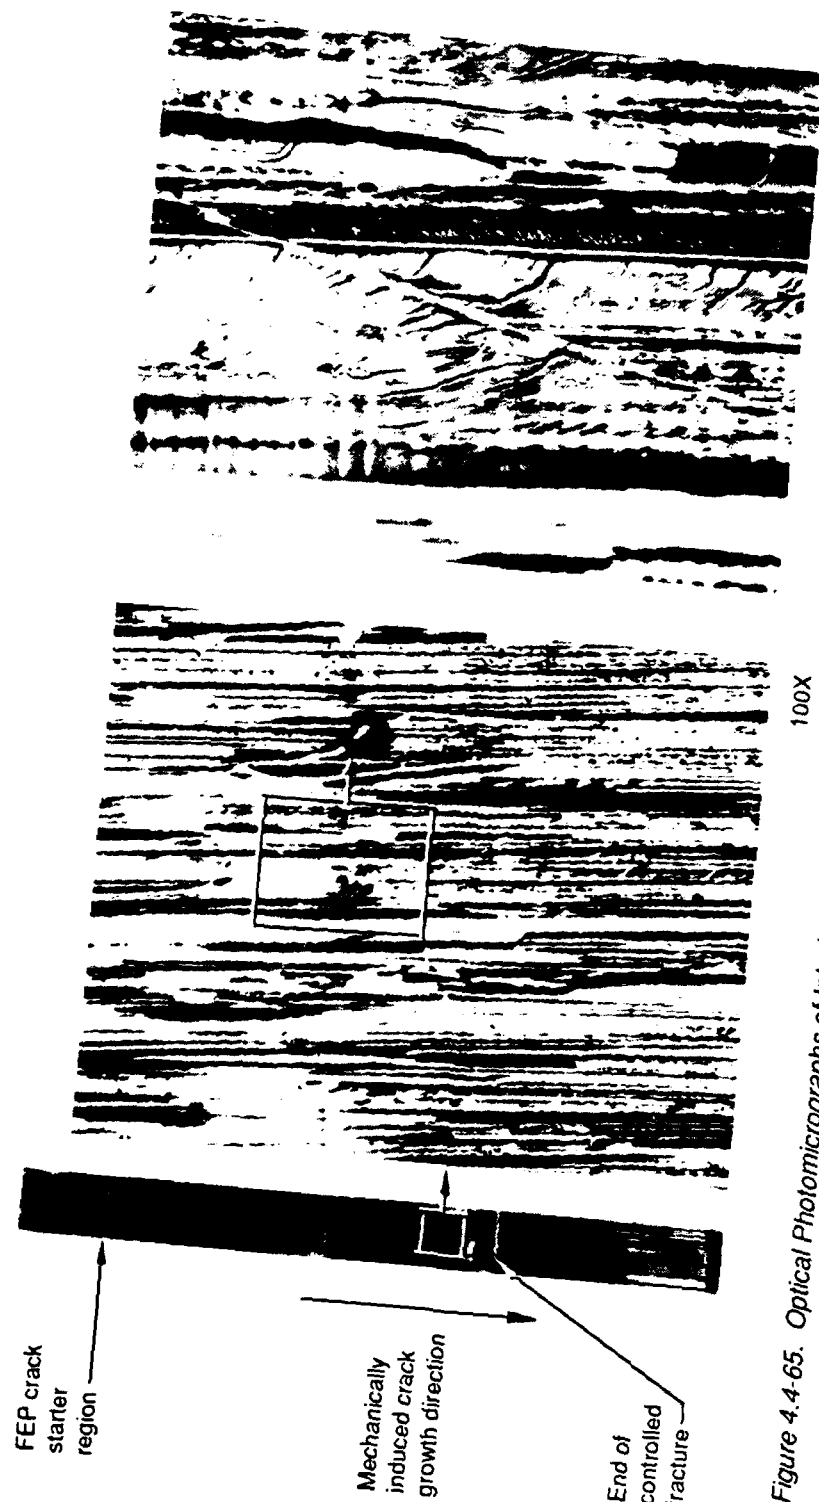
Figure 4.4-65. Optical Photomicrographs of Interlaminar Mode I Tension, 0°/90° Fracture of High Resin Content Specimen

Interlaminar Mode I Tension. Visual observation of the fracture surface revealed a typical smooth, glassy fracture commonly seen in interlaminar Mode I tension specimens at RT/dry condition as shown in Figure 4.4-65. At higher magnification, rivermarks and resin microflow were seen. The SEM analysis revealed a fracture surface with rivermarks as typically observed in RT/Dry specimens (Fig. 4.4-66).

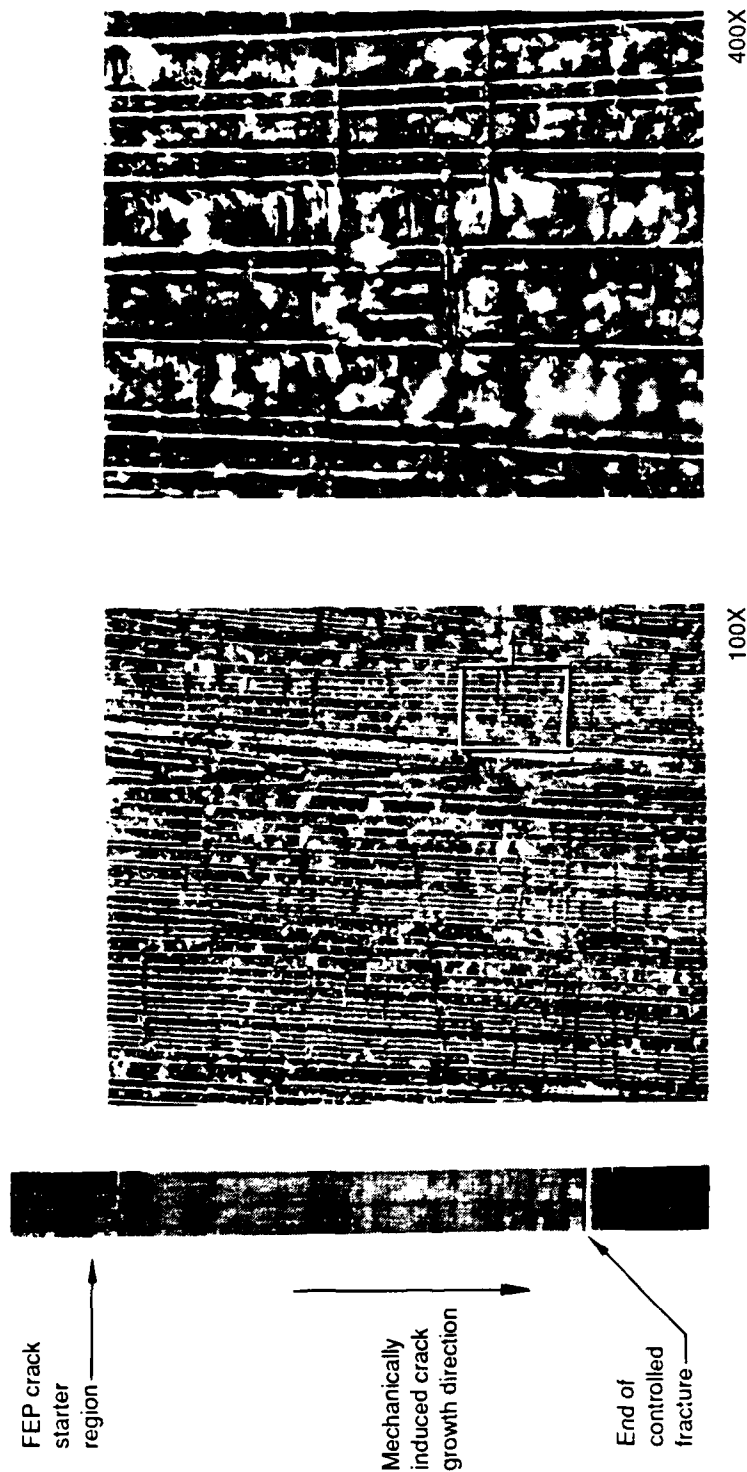
Figure 4.4-67. Optical Photomicrographs of Interlaminar Mode II Shear, 0/90 Fracture of High Resin Content Specimen

Interlaminar Mode II Shear. Visual observation of the fracture surface revealed a flat, milky appearance when held at an angle to the light. Unlike the low resin content specimens, these specimens showed complete wet-out at the resin/matrix interface (Fig. 4.4-67).

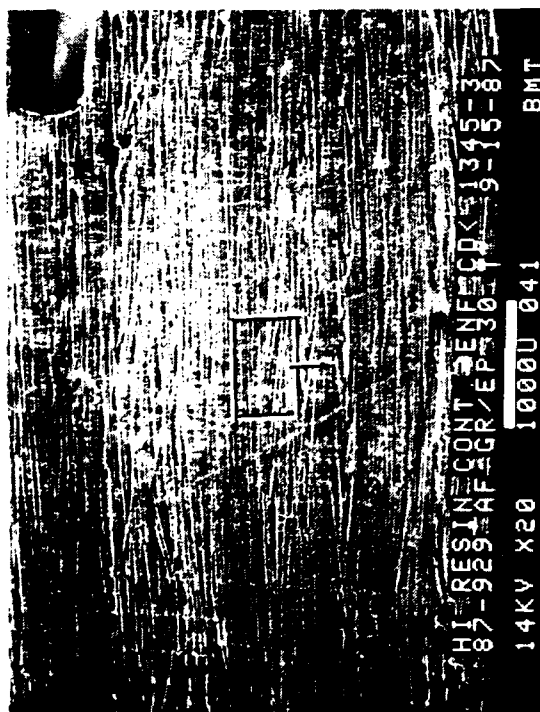
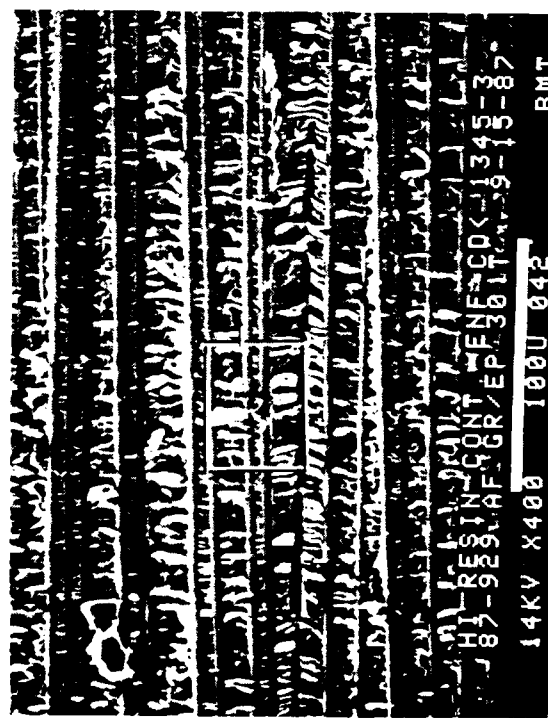
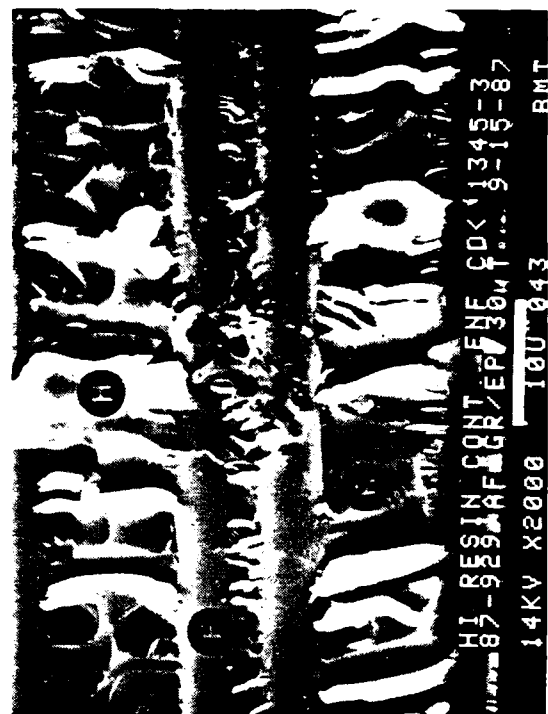
Figure 4.4-68. SEM Fractographs of Interlaminar Mode II Shear, 0/90 Fracture of High Resin Content Specimen

The SEM analysis revealed a fracture surface typically observed in RT/dry specimens (Fig. 4.4-68).

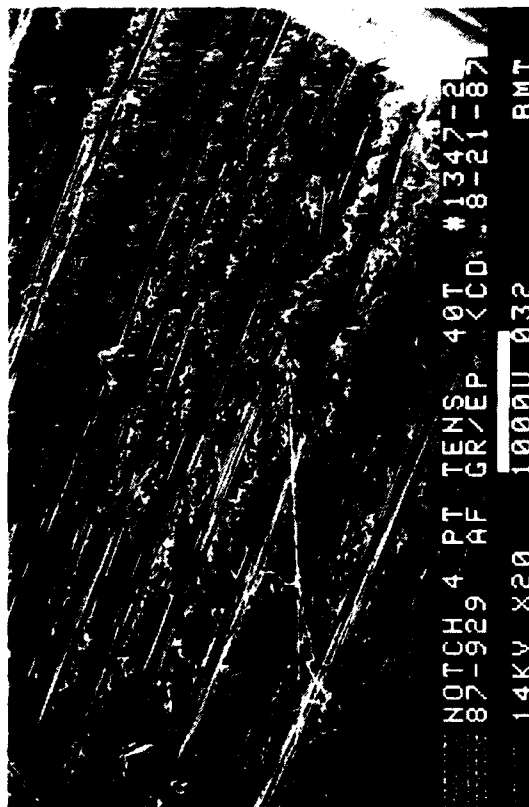
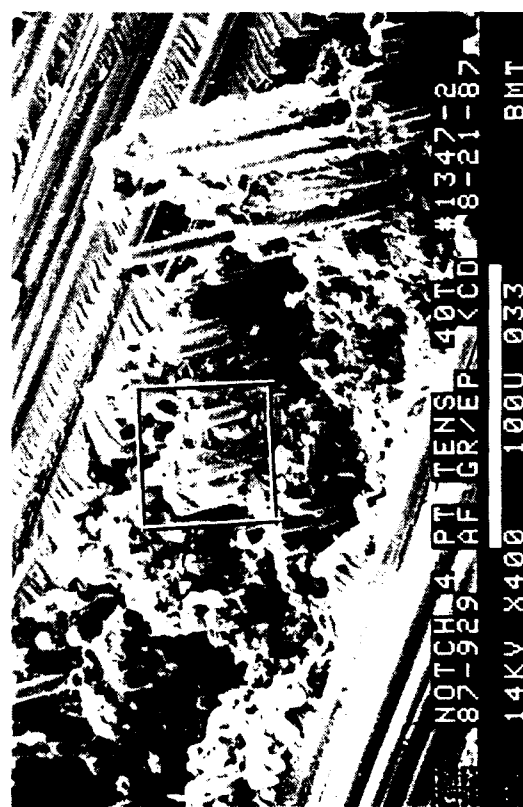
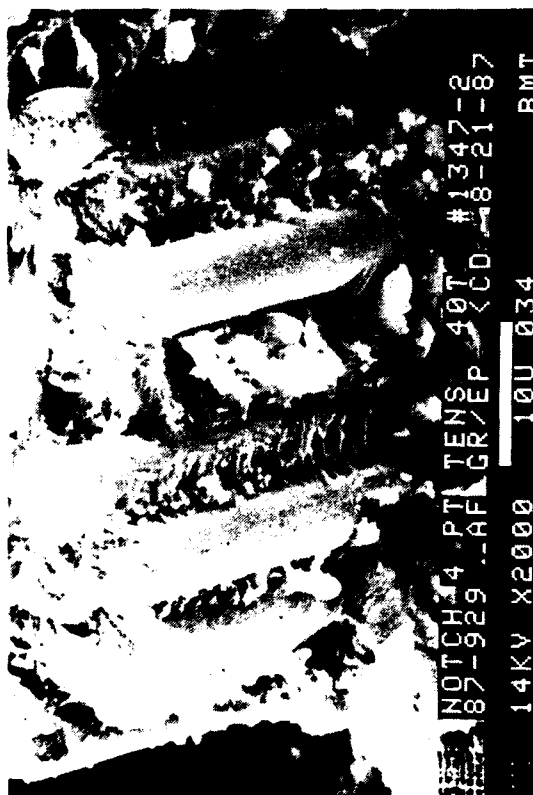
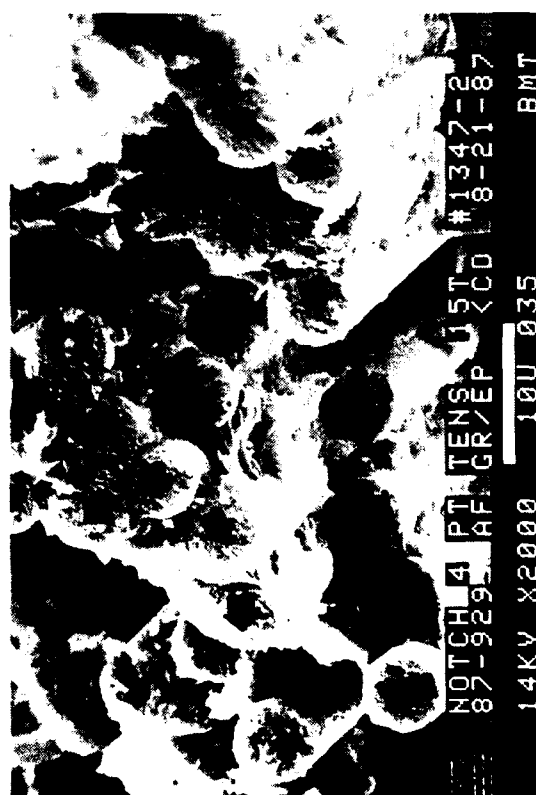
Figure 4.4-69. SEM Fractographs of Translaminar Tension Fracture of High Resin Content Specimen (Concluded)

Translaminar Mode I Tension. Visual and optical observations revealed large fiber pullout regions due to uneven distribution of the added resin film. SEM fractograph showed a cohesive resin fracture at the fiber/matrix interface due to the excessive resin content. The radial patterns on the fiber ends were clearly seen (Fig. 4.4-69).

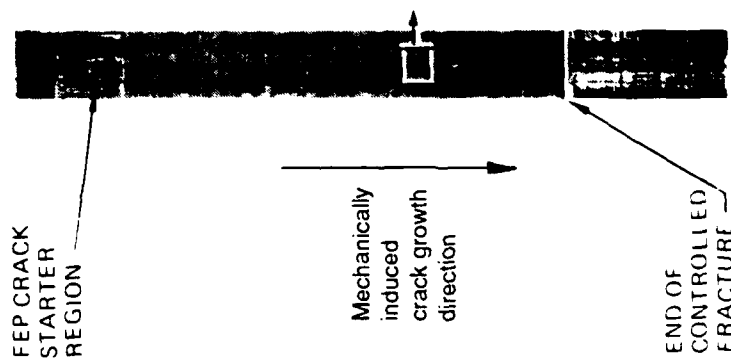
Figure 4.4-70. Optical Photomicrographs of Interlaminar Mode I Tension, 0/90 Fracture of Low Resin Content Specimen

Interlaminar Mode I Tension. Visual observation of the fracture surface revealed the smooth, glassy fracture surface typical of interlaminar Mode I tension specimens at RT/dry. The only noticeable difference was the fiber splinters resulting from the insufficient degree of resin wet-out at the fiber/matrix interface. At higher magnification under the optical microscope, a typical region of low resin content showed lack of fracture features such as rivermarks to indicate the overall crack direction (Fig. 4.4-70).

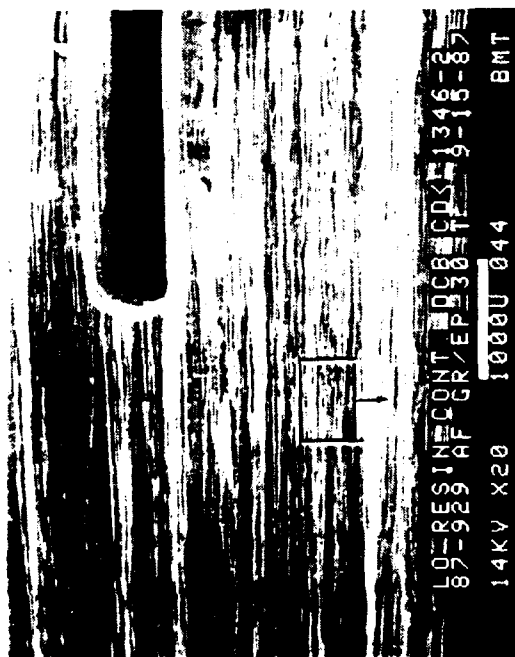
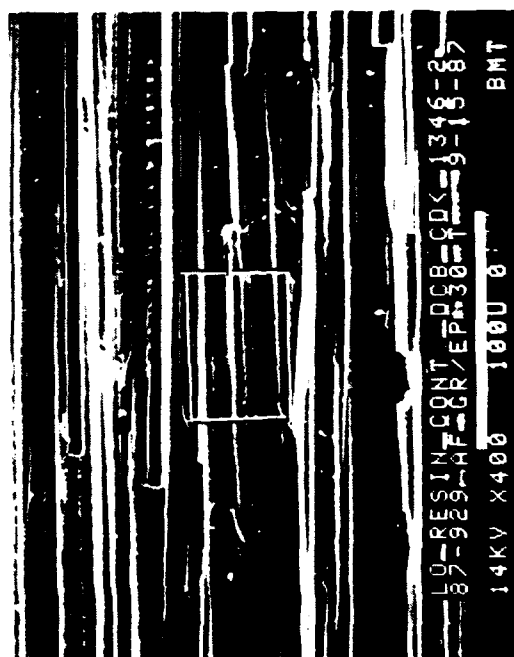
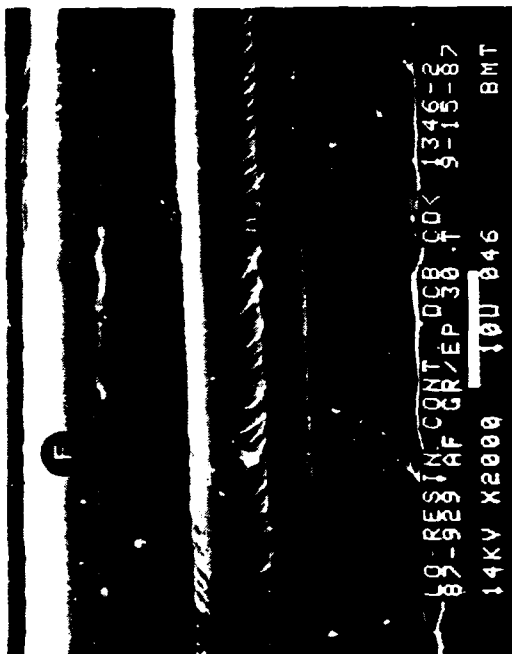
Figure 4.4-71. SEM Fractographs of Interlaminar Mode I Tension, 0/90 Fracture of Low Resin Content Specimen

The SEM analysis revealed a featureless fracture surface (Fig. 4.4-71).

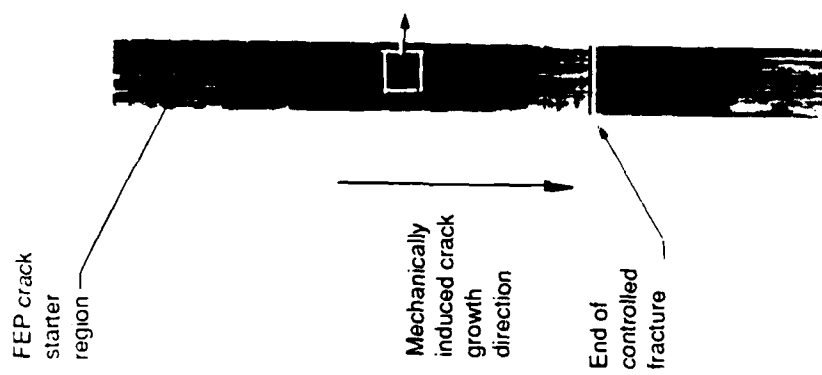
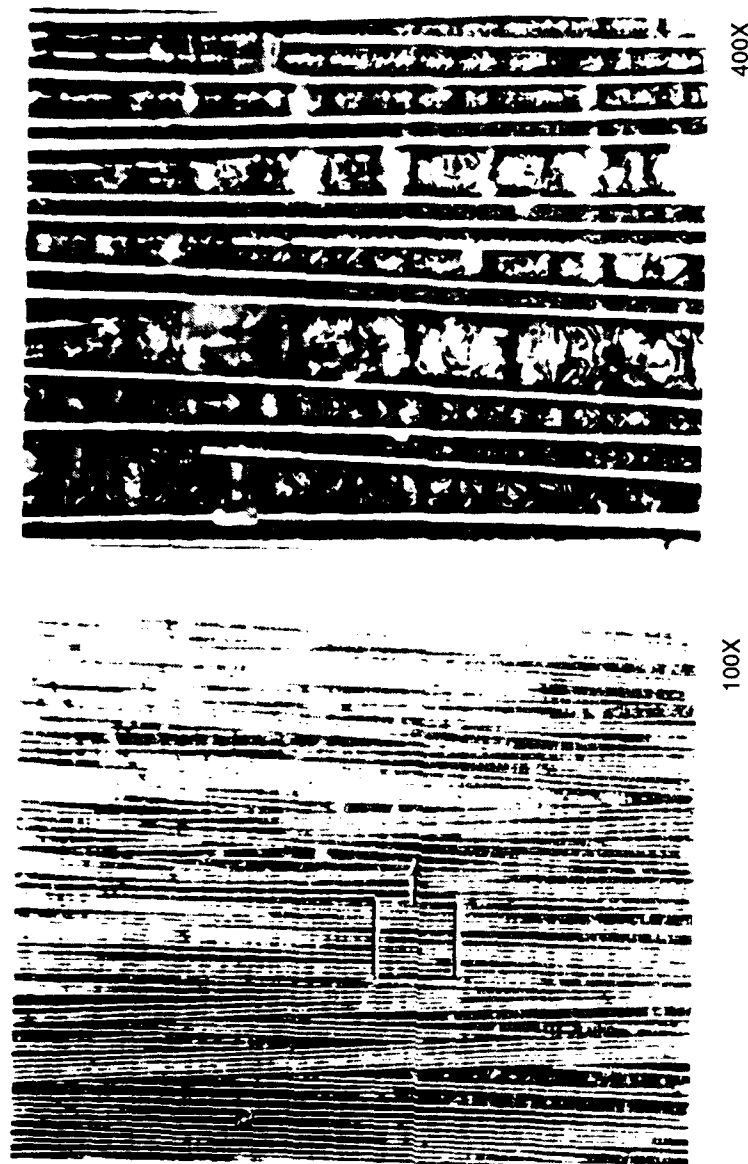
Figure 4.4-72. Optical Photomicrographs of Interlaminar Mode II Shear, 0/90 Fracture of Low Resin Content Specimen

Interlaminar Mode II Shear. Visual observation of the fracture surface revealed a flat but milky appearance when the sample was held at an angle to the light. In some locations on the specimen, there were dark spots indicating voids caused by resin starvation between plies. Although the hackles were present, fine details were difficult to resolve (Fig. 4.4-72).

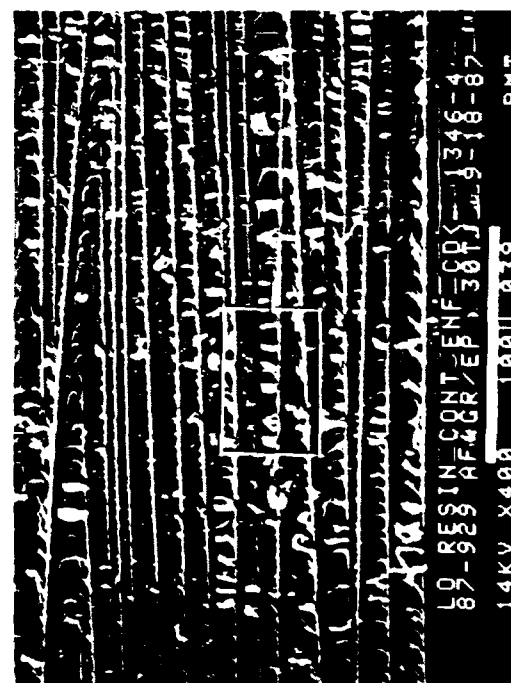
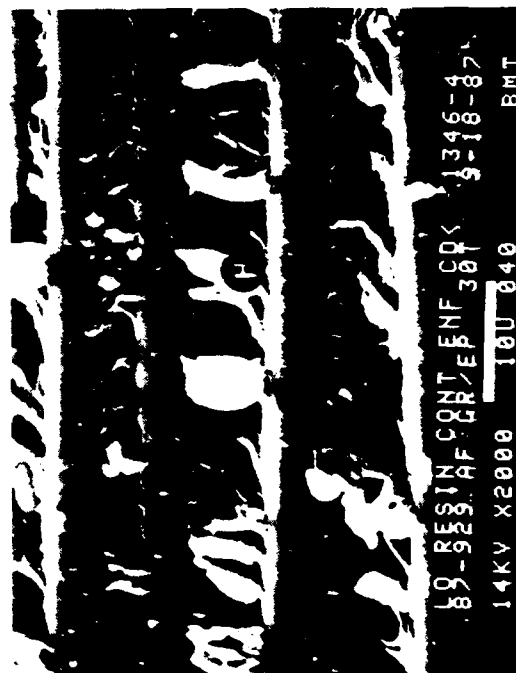
Figure 4.4-73. SEM Fractographs of Interlaminar Mode II Shear, 0/90 Fracture of Low Resin Content Specimen

The SEM revealed a fracture surface with features typically seen in RT/dry specimens, such as hackles and scallops. However, between these hackles, there were many valleys which seemed to have been caused by resin starvation (Fig. 4.4-73).

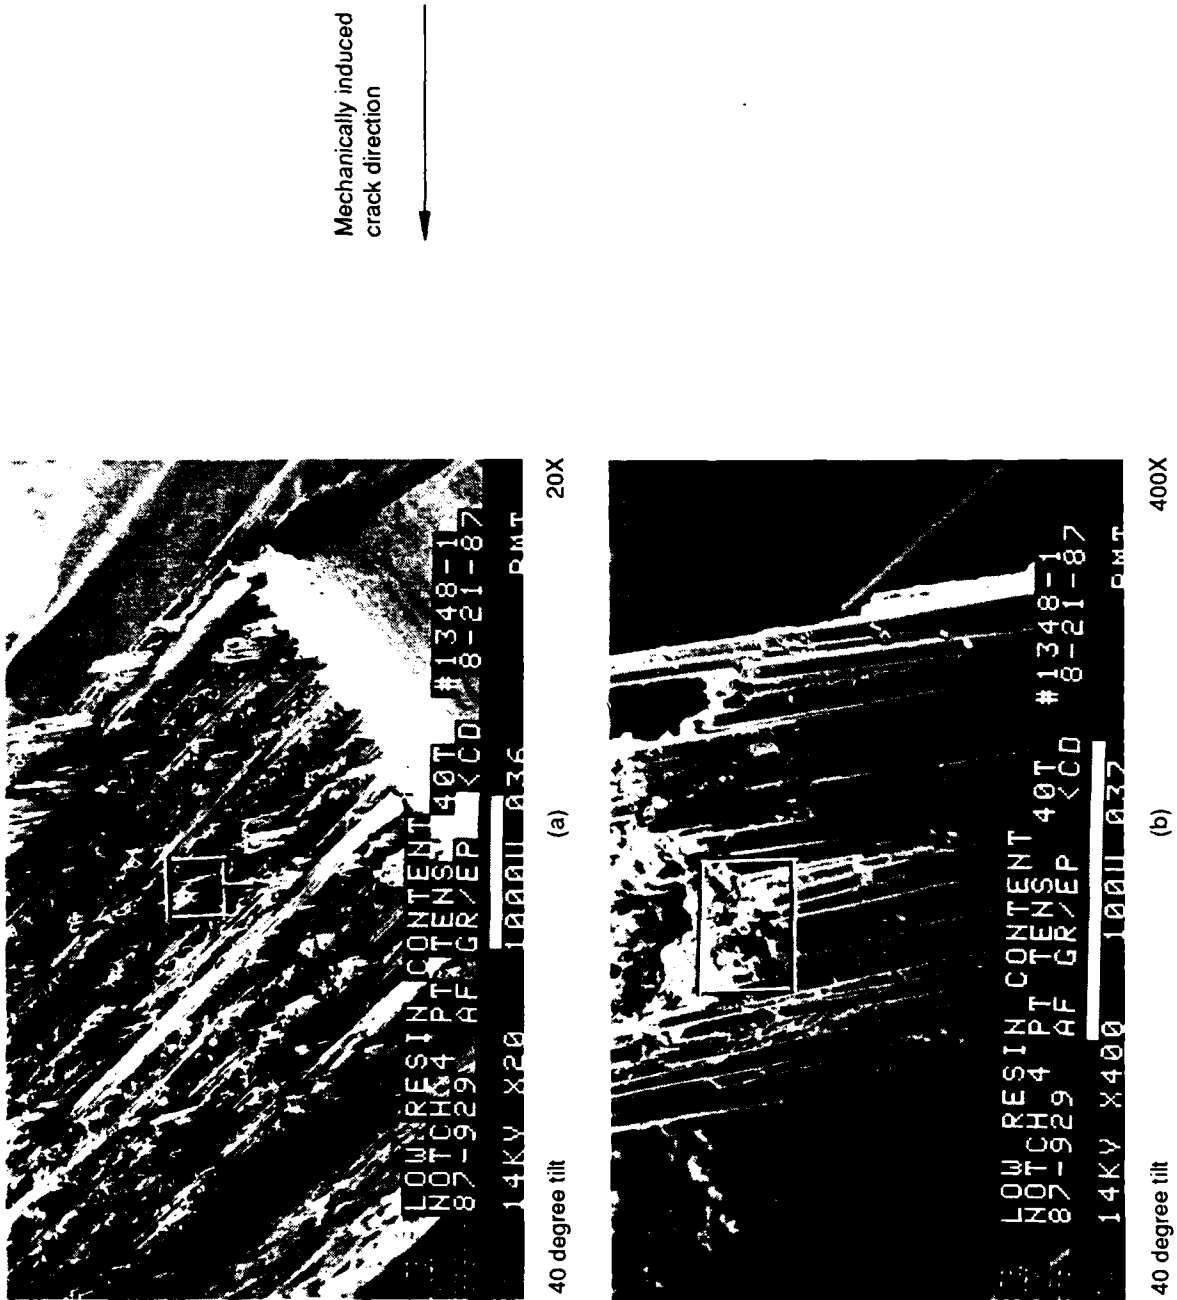
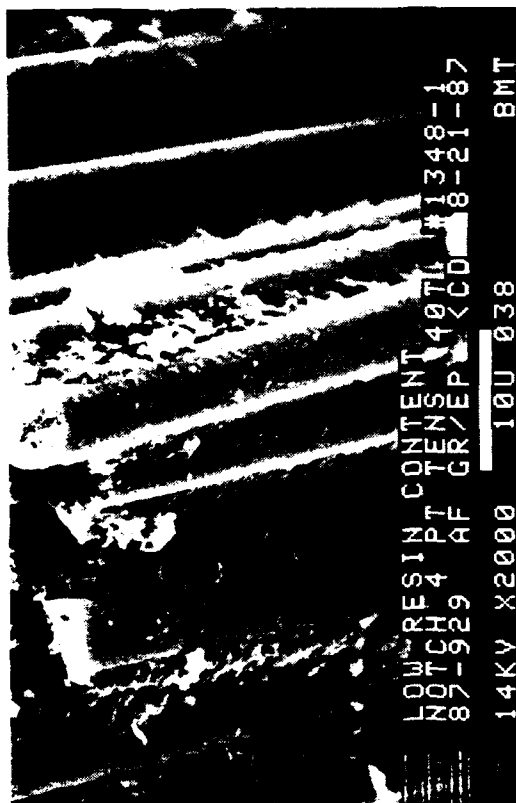
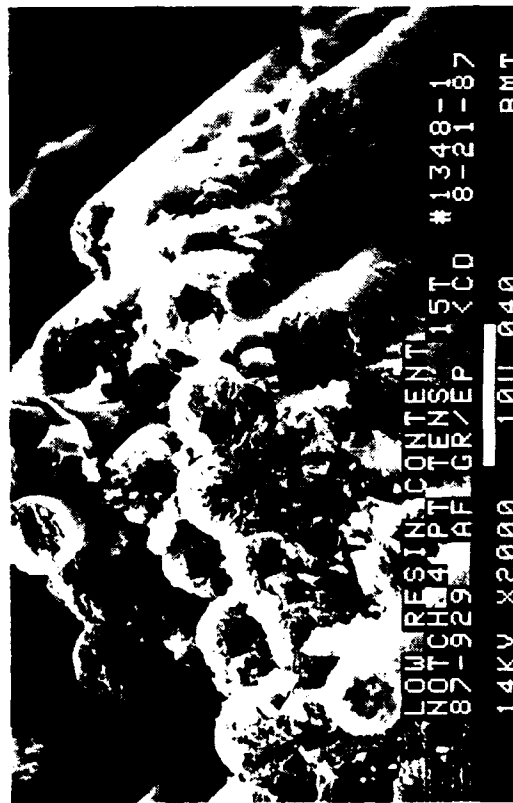
Figure 4.4-74. SEM Fractographs of Translaminar Tension Fracture of Low Resin Content Specimen (Concluded)

Translaminar Tension. Visual, optical, and SEM observations revealed localized fiber pullouts; the protruding fibers were unevenly distributed on the fracture surface. The fiber/matrix adhesion seemed poor as evidenced by the lack of resin fracture along the sides of the fibers. However, the radial patterns essential for determining the crack direction were clearly seen (Fig. 4.4-74).

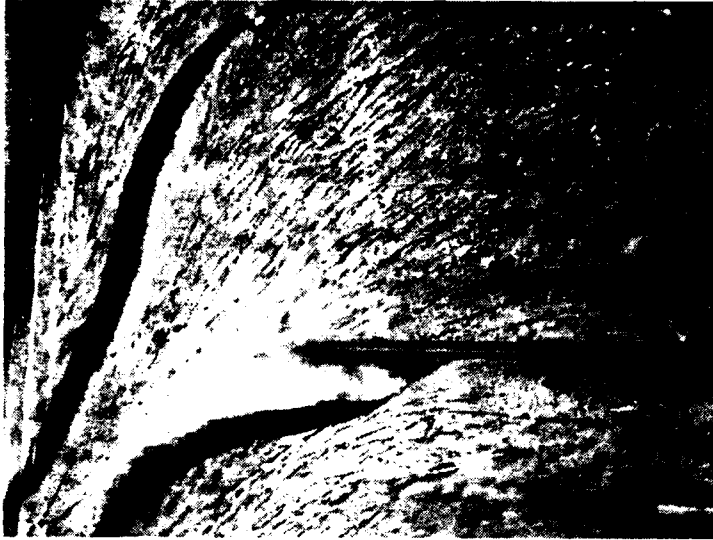
Figure 4.4-75. Optical Photomicrographs of Interlaminar Mode I Tension, Room Temperature, Fabric Fracture

Interlaminar Mode I Tension. Visual inspection revealed a flat, smooth surface. However, because of the weave pattern, the fracture surface appeared less reflective or glassy than unidirectional tape.

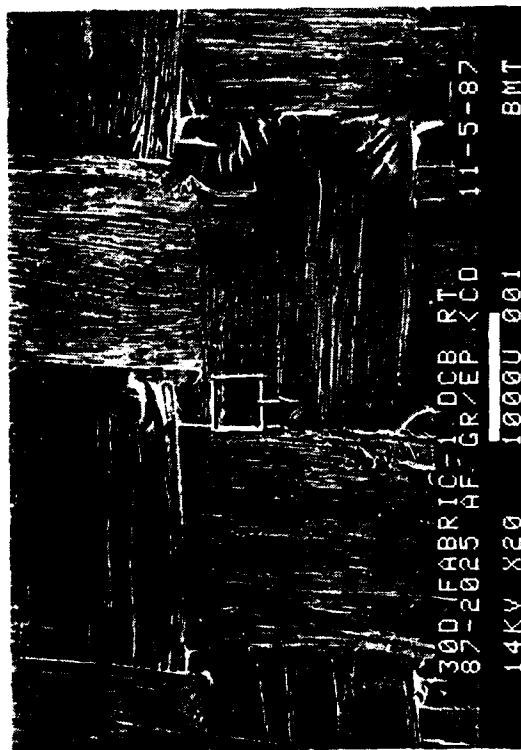
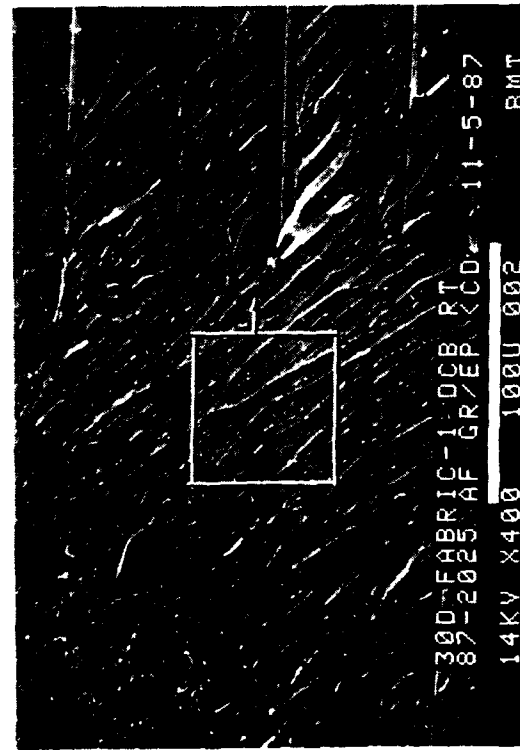
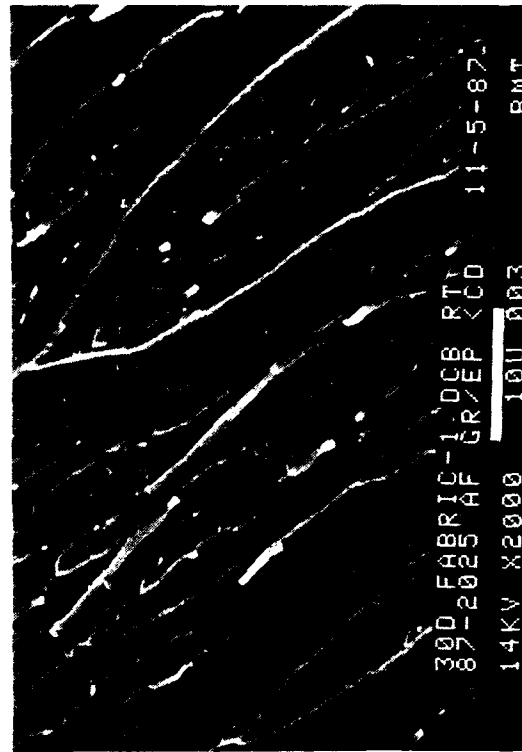
Figure 4.4-76. SEM Fractographs of Interlaminar Mode I Tension, Room Temperature, Fabric Fracture

SEM analysis confirmed the optical results. However, because the rivermarks in a single region are not always consistent with those in other regions, several resin-rich regions should be observed before making any conclusions on the crack propagation direction (Fig. 4.4-76).
